STABILITY OF THREE ROCK SLOPES

WILLIAM PATRICK STEWART

A THESIS

DEPARTMENT OF CIVIL ENGINEERING

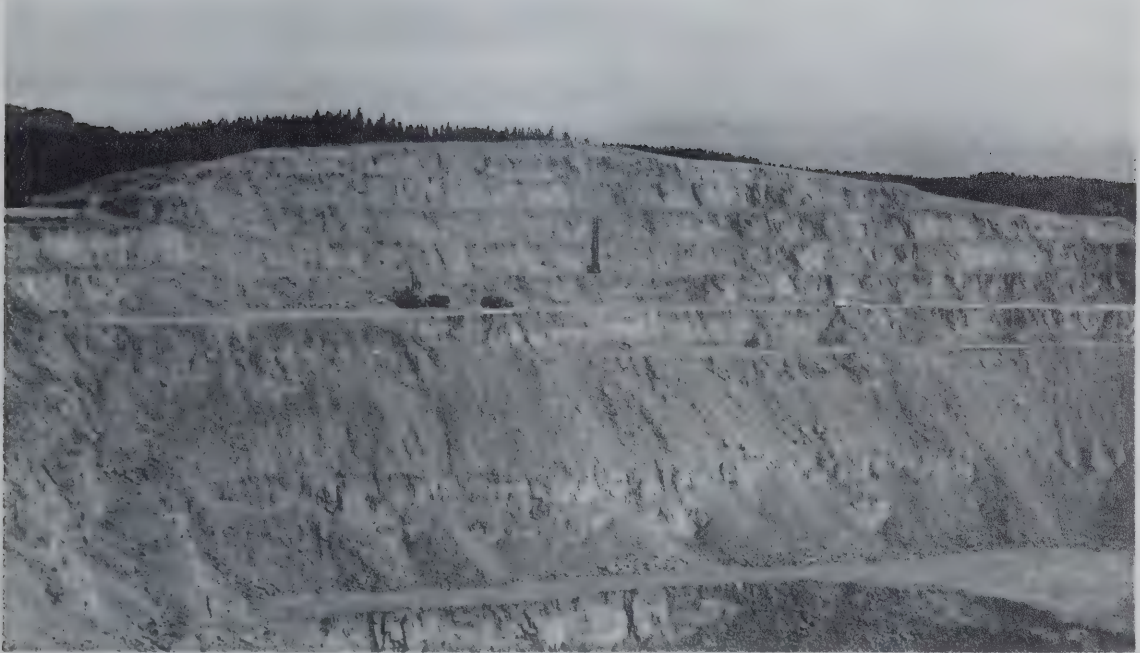
Fig.3.2 General view of North wall, Brenda Mines Ltd.

Two small slides occurring in the North wall of the pit were selected for the case histories. An over-all view of the North wall is shown in Fig.3.2. These slides were selected because the surfaces on which sliding occurred were fully exposed for observation and measurement. In addition it was assumed that the pre-failure geometry was defined completely by adjacent wall and floor sections. The slides were accessible from the benches above and below, and the right sides and walls were therefore measured by tape and theodolite survey. Check points on the right sides of the slides indicated an accuracy of about 3%. As can be seen in the photographs in Figs.3.3 and 3.5, the slides have a wedge shape, the right sides being very planar, but the left sides being very broken and rough. It is apparent that sliding in the usual sense could not have occurred on the broken left surfaces. For the left hand sides of the slides, the average inclinations were estimated using a Brunton compass. In

Slides are between second and third bench  
above drill rig.

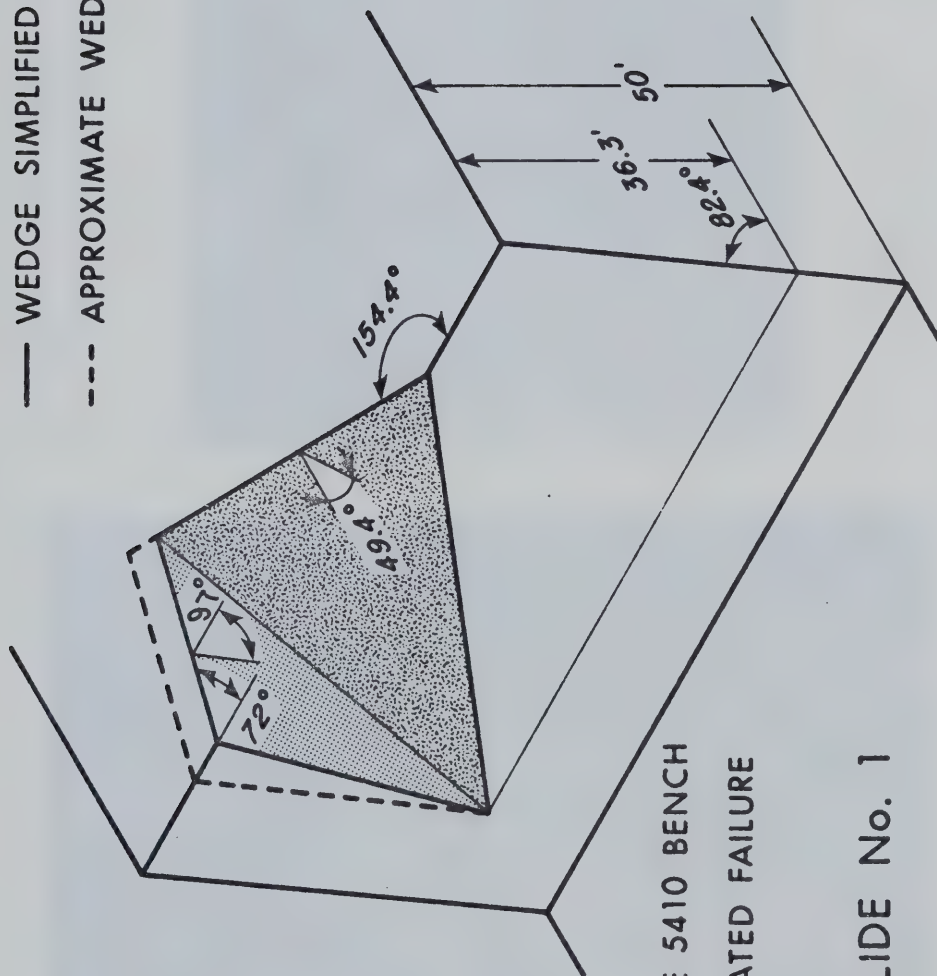
BRENDA SLIDE No. 1

— WEDGE SIMPLIFIED FOR ANALYSIS  
 --- APPROXIMATE WEDGE SHAPE IN FIELD

NEAR HV 5 ABOVE 5410 BENCH  
 MOLYBDENITE COATED FAILURE  
 SURFACE

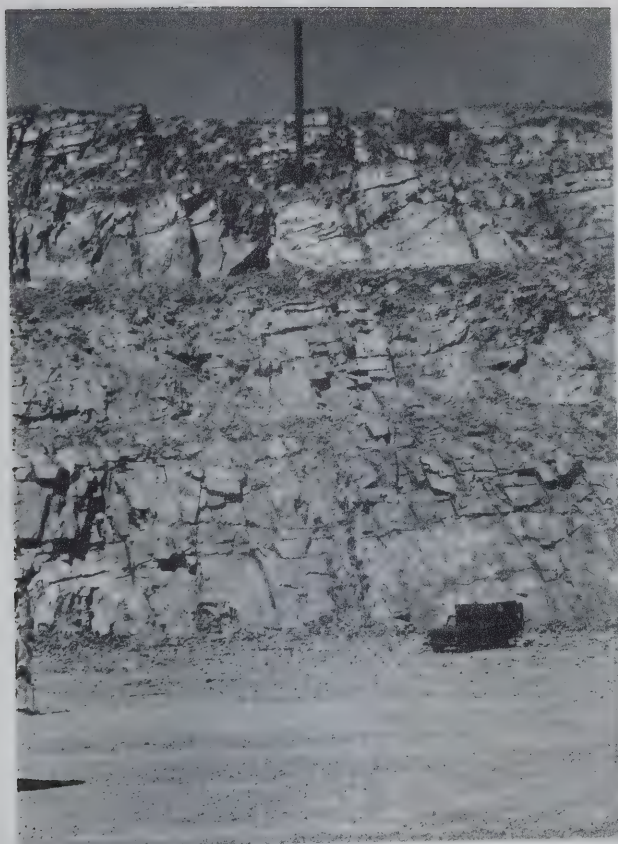
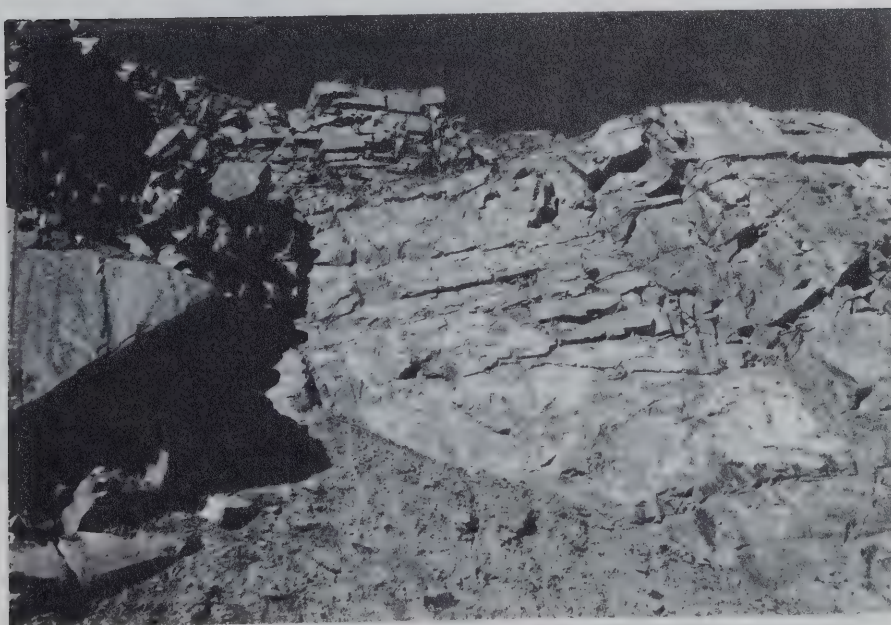
Fig.3.5 Photographs of slide no. 2 at Brenda Mines Ltd.

The geometry of slide no.2 is shown in Fig.3.6. The dashed lines represent the approximate shape of the slide in the field. As mentioned previously the large block at the lower left (visible in the photograph of Fig.3.5) was considered as the edge of the main slide mass. The portion of the right side of the slide that remained in place is discussed in Chapter 5. Again the surface was inspected and the material occurring in patches over the surface was identified as calcite. It was assumed that patches of calcite on the mass that slid corresponded to the "bare" portions of the failure surface that remained on the wall. Samples used for testing had this correspondence of patches of calcite on the two halves of the samples.

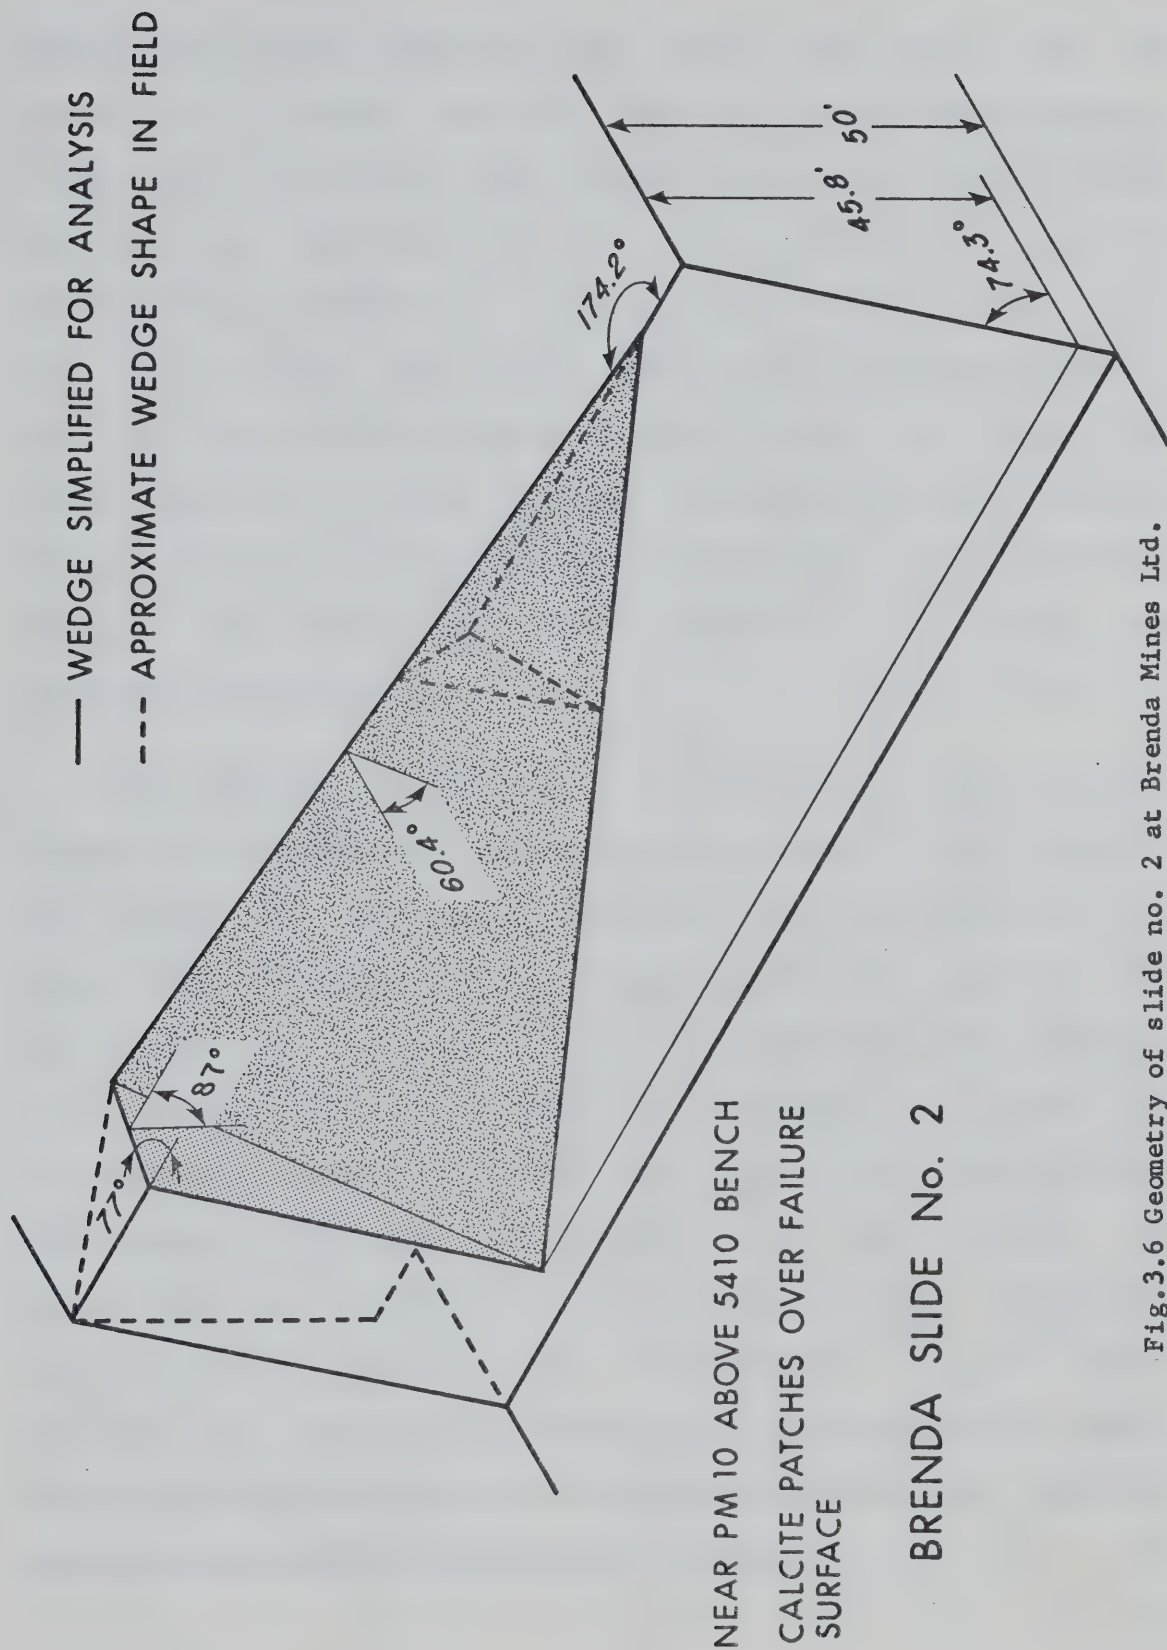
Fig.3.6 Geometry of slide no. 2 at Brenda Mines Ltd.

upper part of this surface than from the lower part to establish a stable surface (see de Freitas and Watters, 1973). For the reasons noted above the measured dip of this surface was increased in the idealization to a point at which sliding occurred on the right base of the slide only and this dip was used in the assumed pre-failure geometry. The right surface was inspected and a piece was taken for identification of the surface minerals. The main mineral forming the surface coating was identified as molybdenite ( $\text{MoS}_2$ ), but contained minor amounts of a variety of secondary minerals.

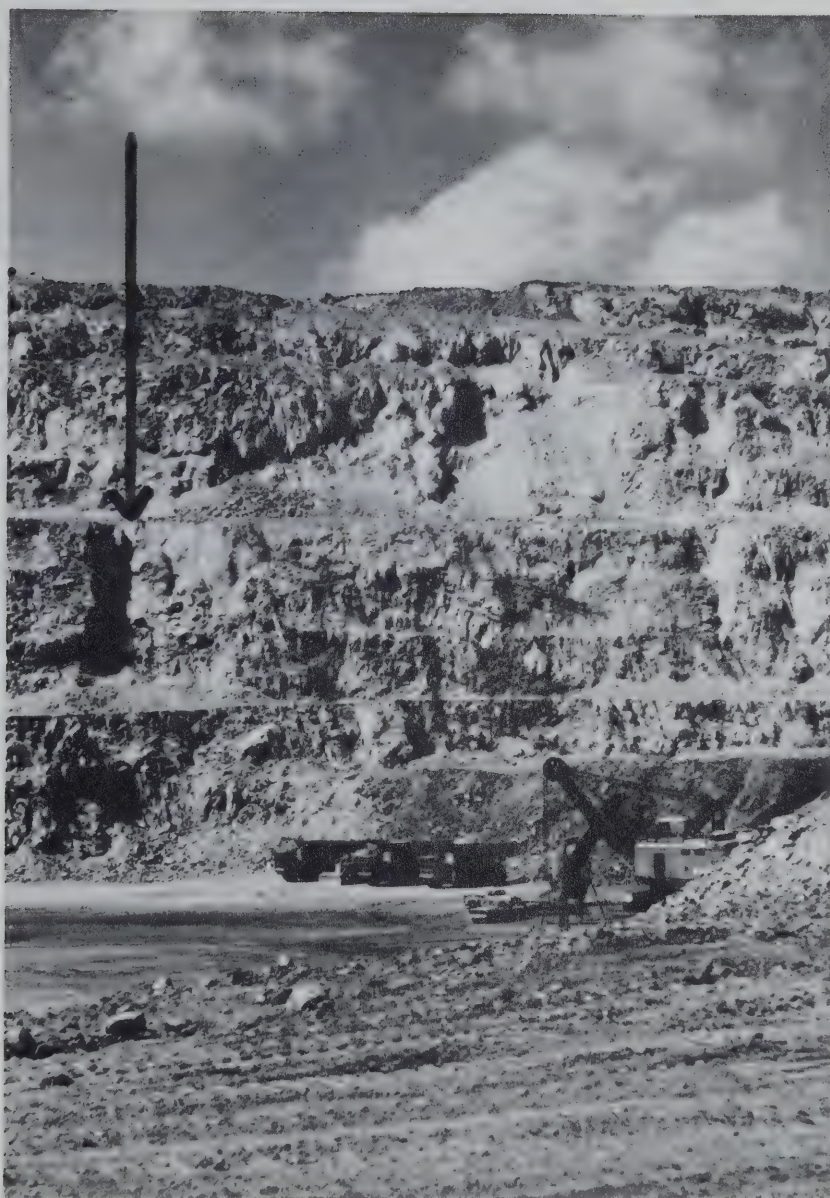
Fig.3.8 Photograph of slide at Endako Mines Ltd.

The slide chosen for analysis occurred in the east pit and is shown in the photograph in Fig.3.8. Unlike the case histories at Brenda Mines, this slide area was not

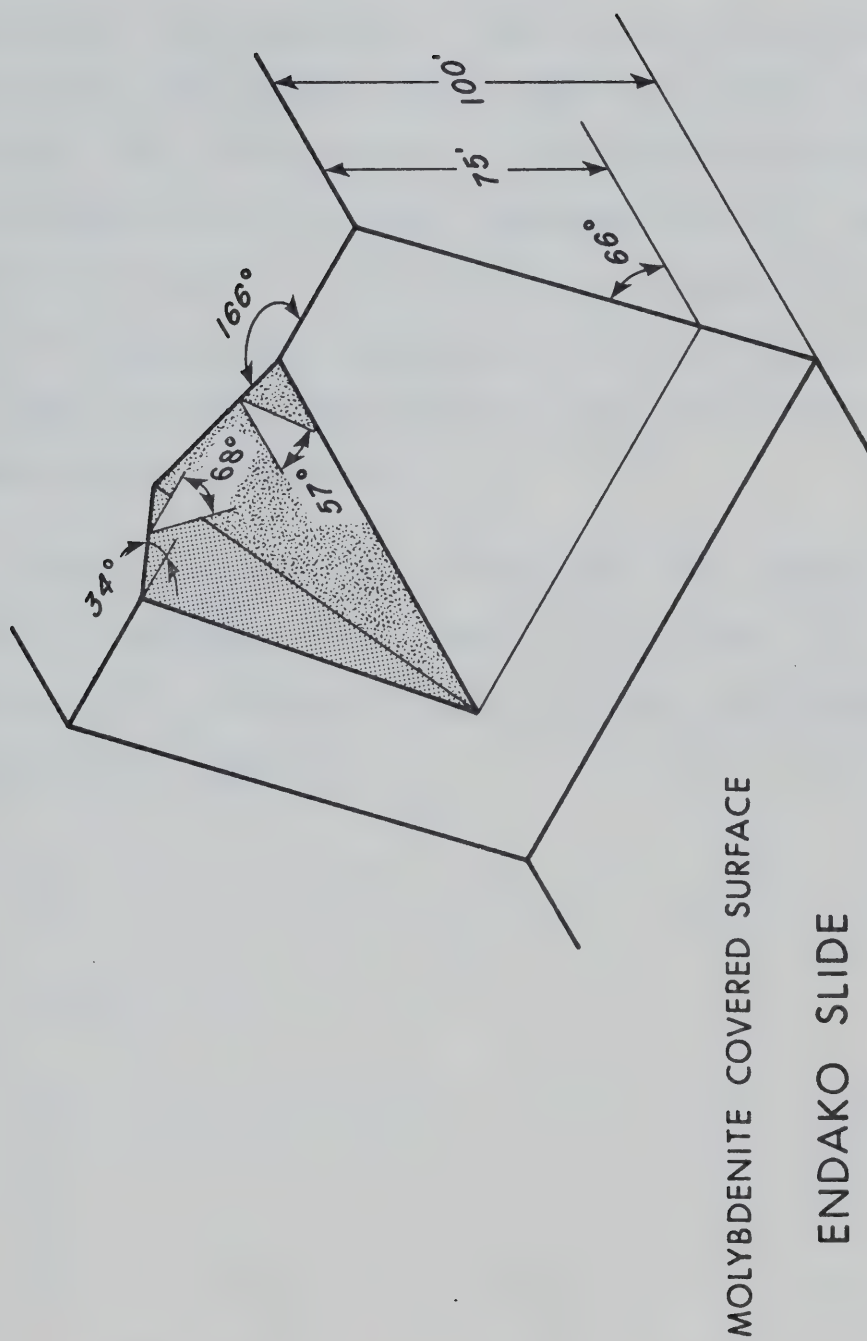
Fig.3.10 Geometry of slide at Endako Mines Ltd.

accessible and was partially covered with debris from above. A theodolite triangulation survey was carried out, but the results were somewhat suspect because there were not definite points on the slide to survey. A triplet of overlapping photographs of the slide was available and a contour map was prepared from these by Miller Engineering Services Ltd. of Vancouver. A wedge-shaped slide was fitted to this contour map by trial and error and the results are shown in Fig.3.9. The resulting geometry is shown in Fig.3.10. The failure surface on the right side of the wedge was dark in colour, and given the nature of the mine, was assumed to be molybdenite.

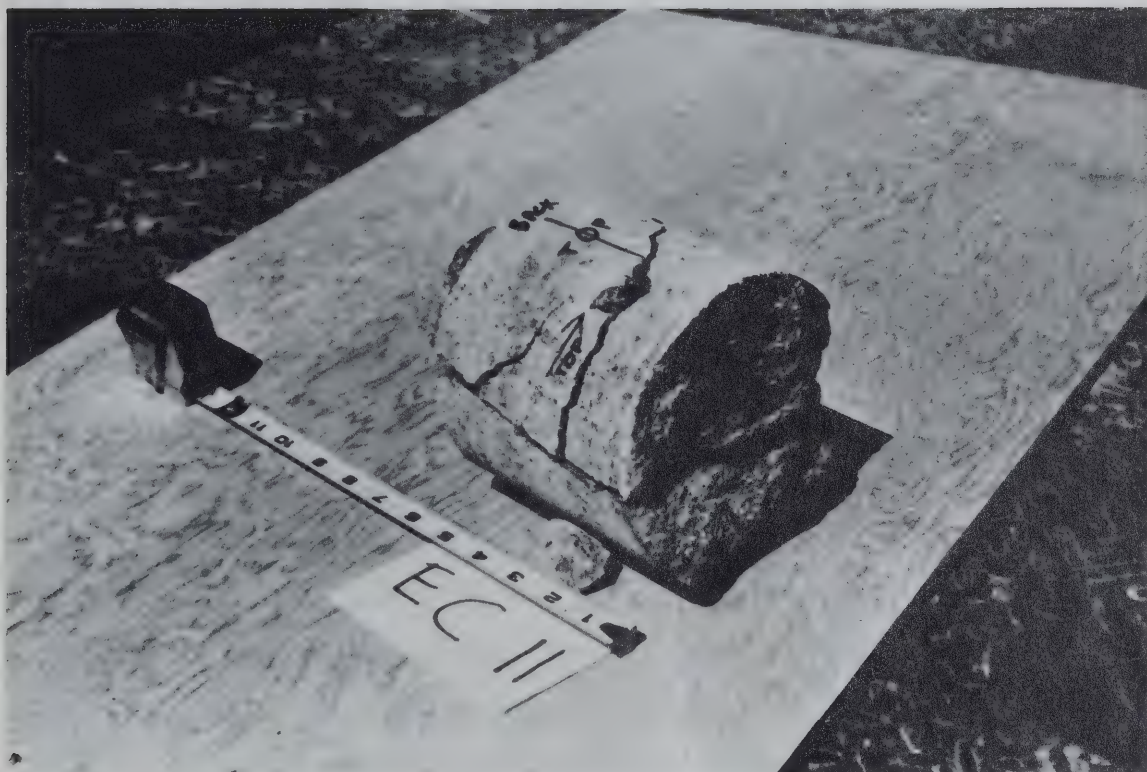
Fig.4.2 Example of core obtained from drilling.

The main problem encountered in this sampling program was the fracturing of samples which prevented the obtaining of large intact samples for testing. It had been hoped that the use of the 6 in. double-wall core barrel would reduce this problem but the cores drilled with this barrel were as fractured as those drilled with the single-wall barrel and drilling took considerably longer because of the increased cutting surface area. Upon examination of the fractures and similar fractures in block samples it was realized that some

of these were mineralized. This indicates that at least some of the fractures existed before the sampling and therefore any sampling technique would give rise to fractured samples. It was felt undesirable to test samples in which the sample had been epoxied together as any misalignment could give a step in the profile of the sample.

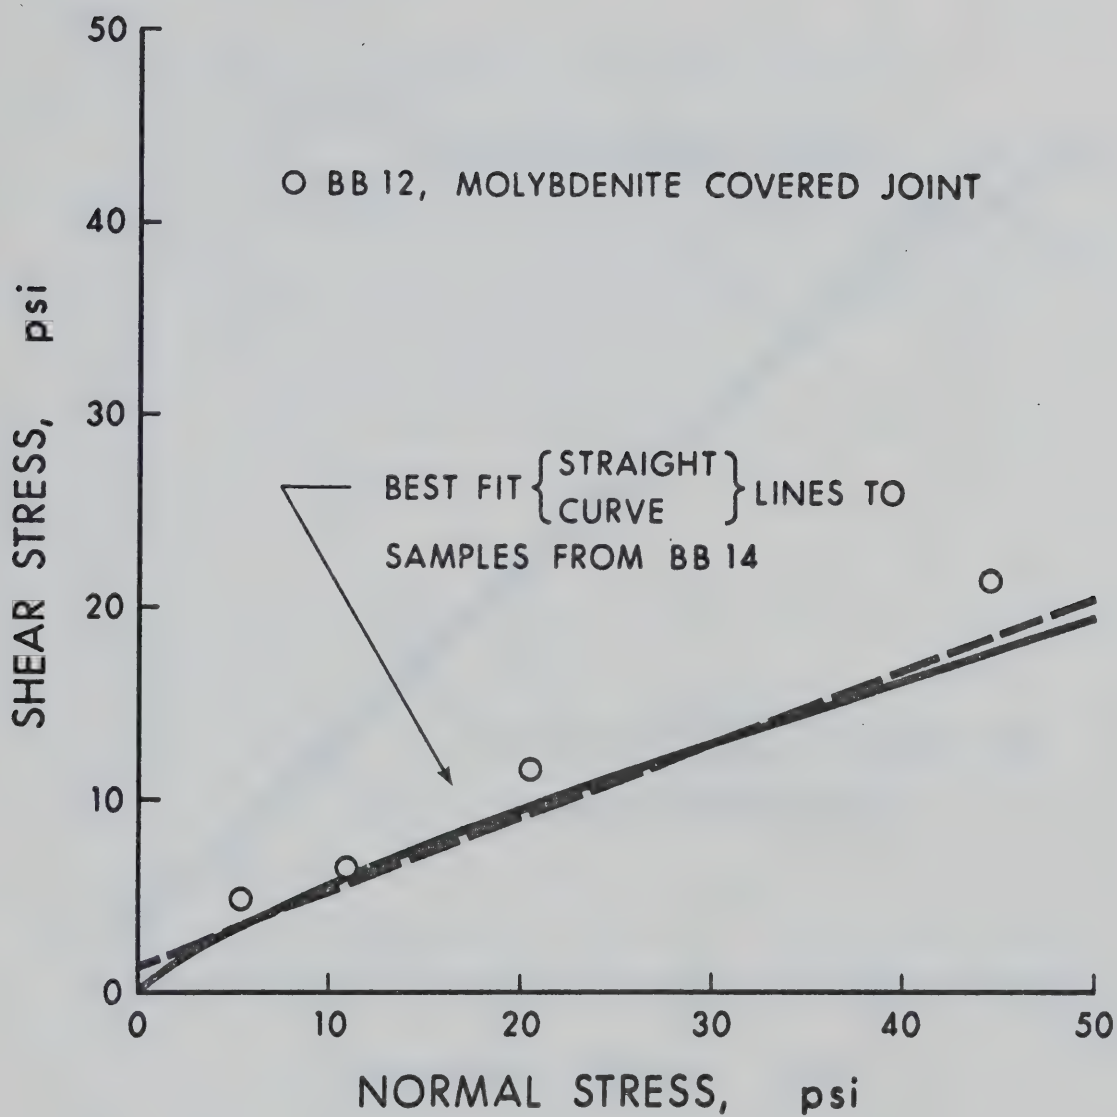
Fig.4.13 Comparison of strength of large molybdenite sample with strength envelopes of smaller samples.

Figs.4.13 and 4.14. The strengths measured on the large samples fell well within the range of strengths measured on the small samples.

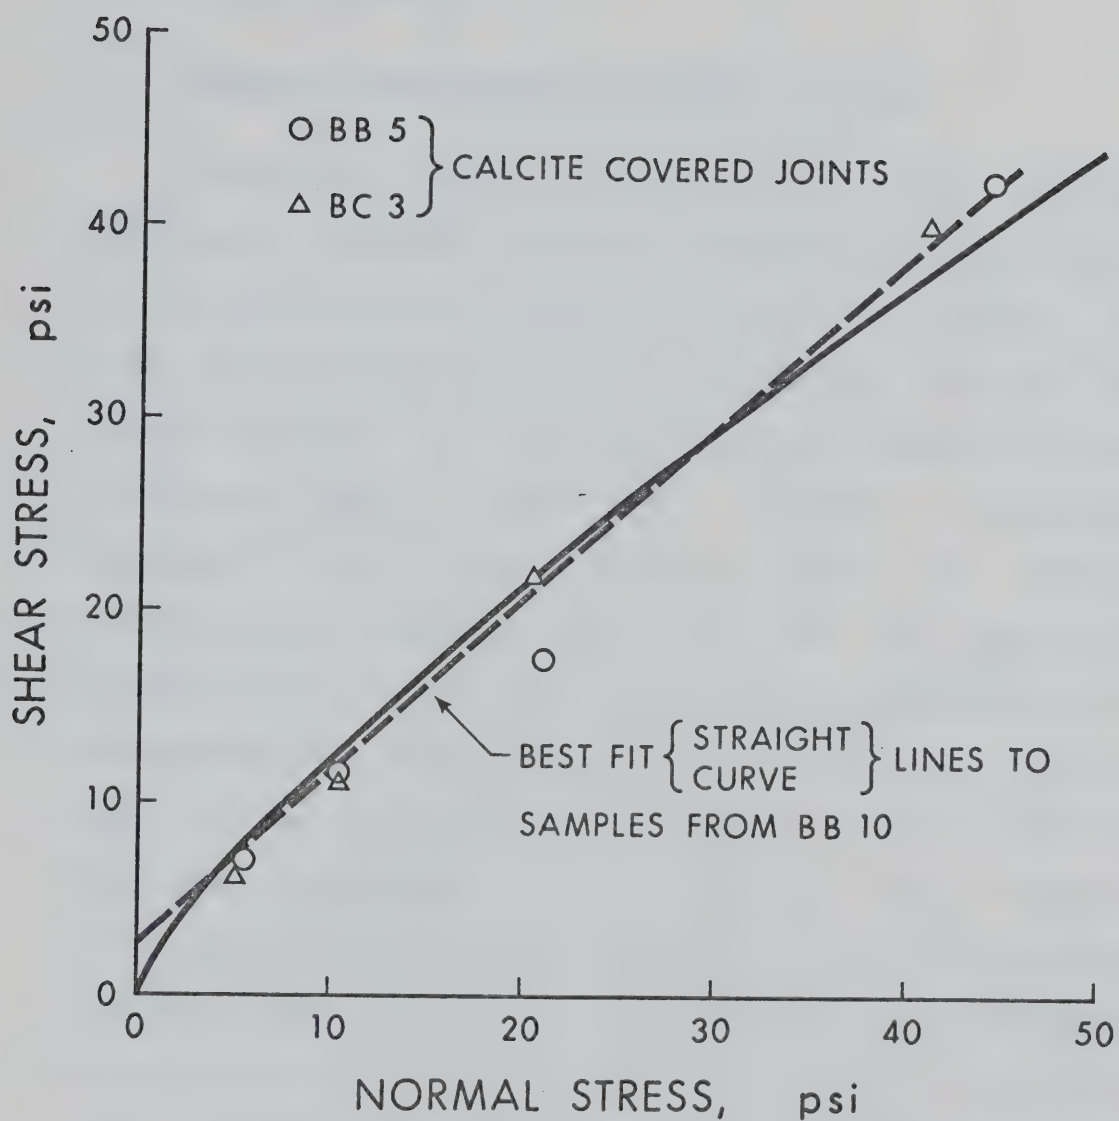
Fig.4.14 Comparison of strength of large calcite samples with strength envelopes of smaller samples.

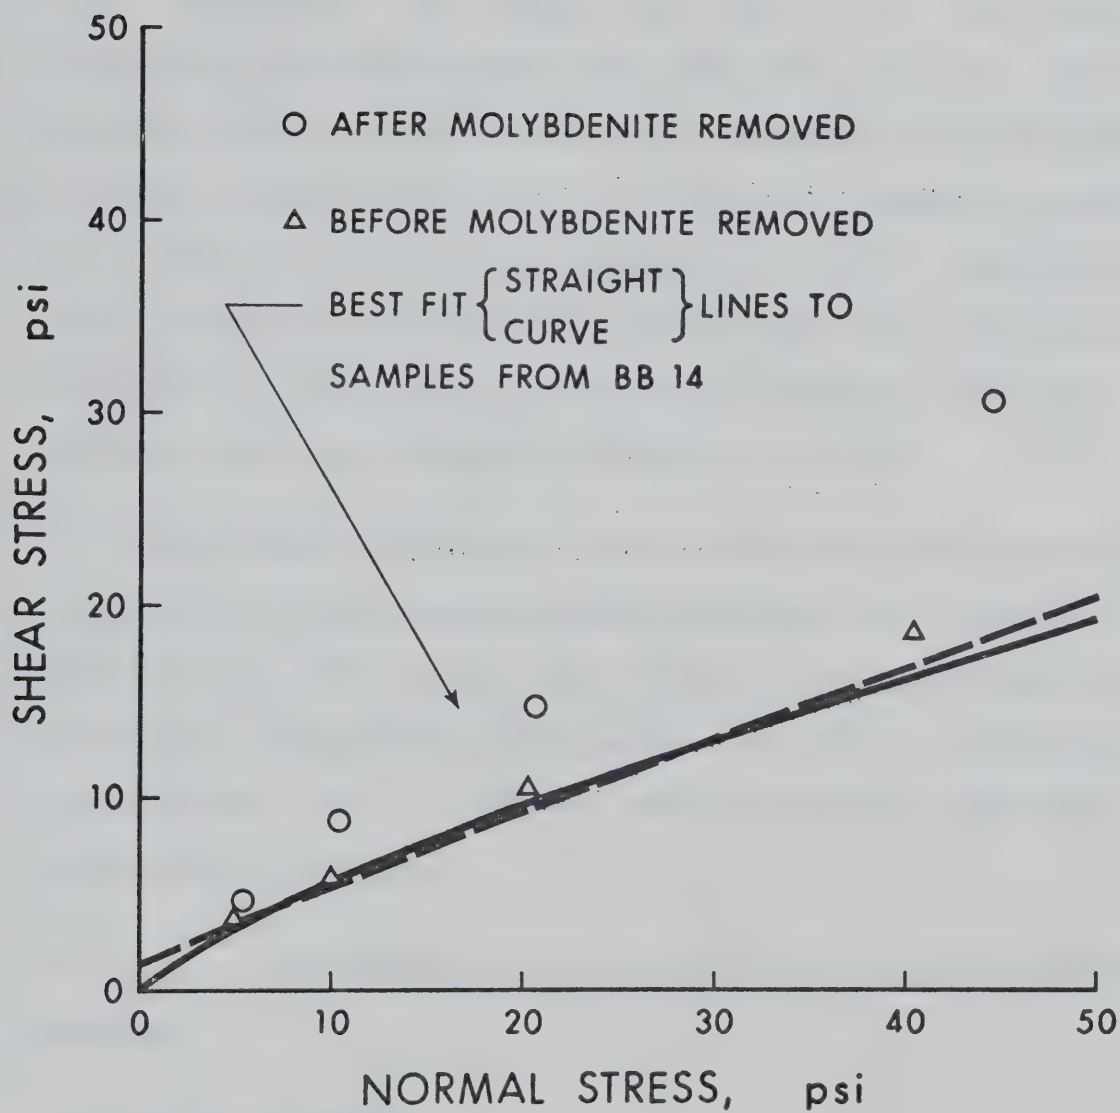
In order to obtain a measure of the effect of the molybdenite coating on joint strength, the molybdenite was dissolved off the surface of one of the samples (2-BB14) using nitric acid and the sample was retested. The surface profile was measured before testing and the calculated surface parameters remained essentially unchanged from those obtained before the initial testing. After testing the sample did not show the characteristic fine blue-gray streaks exhibited by all the molybdenite samples so it is felt that most, if not all, of the molybdenite was removed. As can be seen in Fig.4.15, considerably higher strengths were measured after the molybdenite was removed. The exposed material that had been under the molybdenite was a phyllosilicate, probably mainly chlorite. Chlorite has a sheet like structure but there is electrical bonding between the sheets, as opposed to the weak intermolecular bonds between molybdenite sheets (Berry and Mason, 1959).

Fig.4.15 Effect of molybdenite on strength.

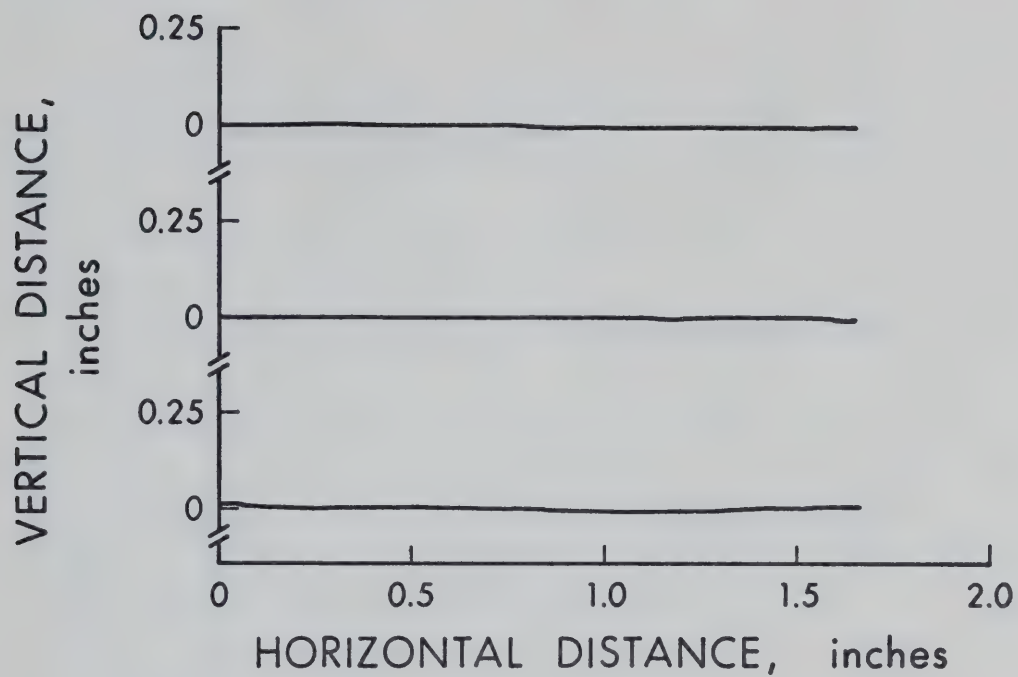
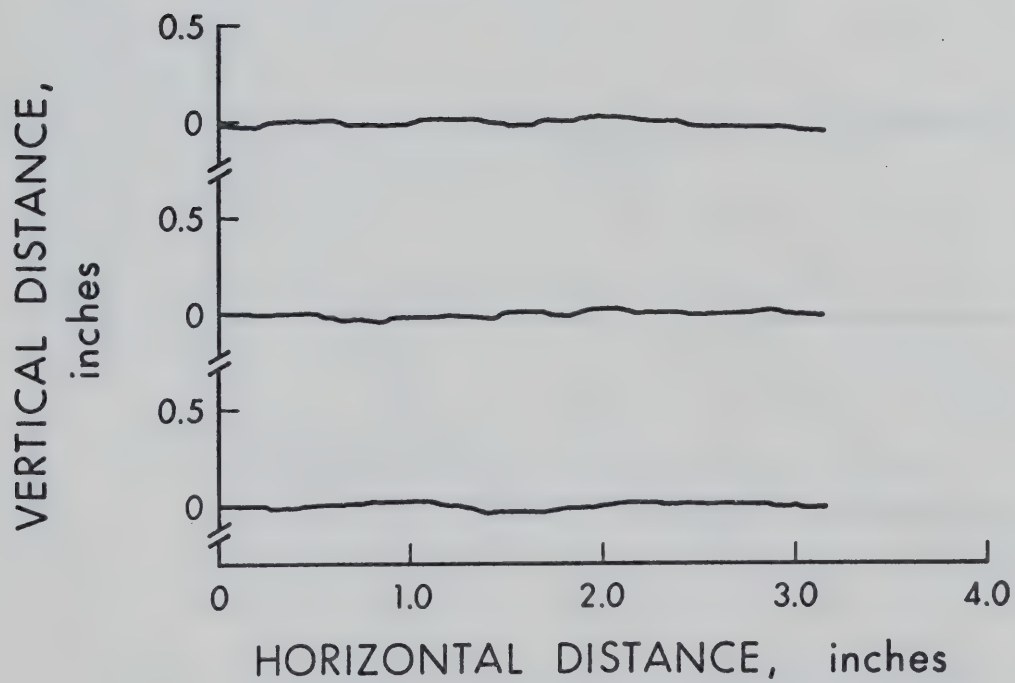
Some typical values of joint roughness parameters and strengths are given in Table 4.1. The main conclusion from this table is that it is the joint material, not the roughness which dominates the strength values. A factor of 2 to 3 in roughness parameters gave very little difference in strength, but a similarly rough surface in different materials gave very different strengths. Some typical surface profiles drawn at a natural scale are given in Figs.4.16 to 4.18.

Fig.4.16 Roughness plots for Brenda molybdenite samples.

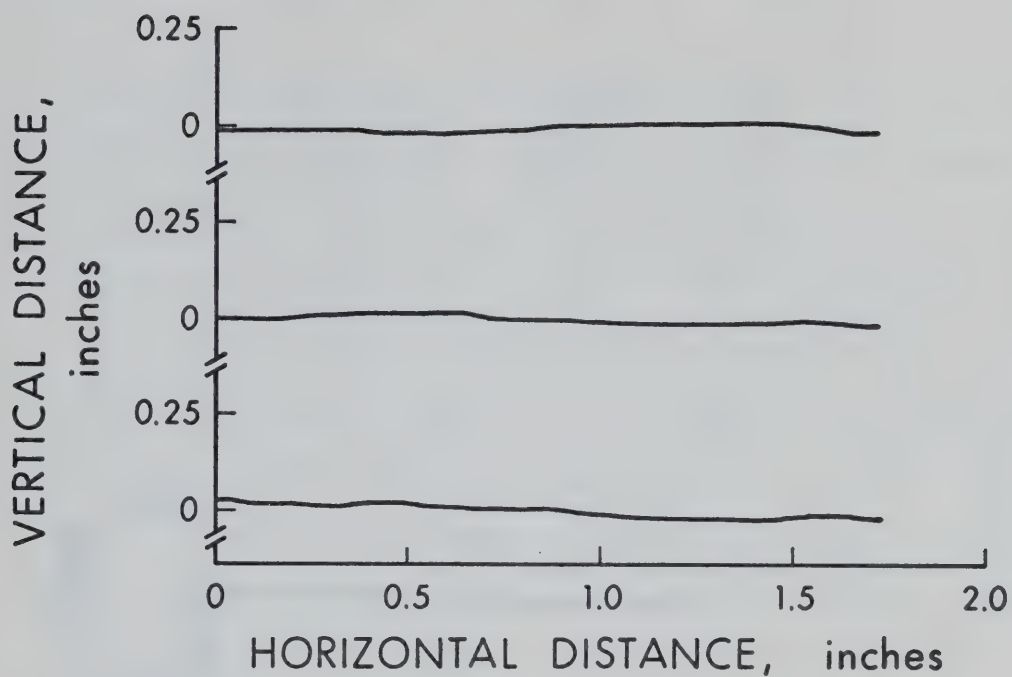
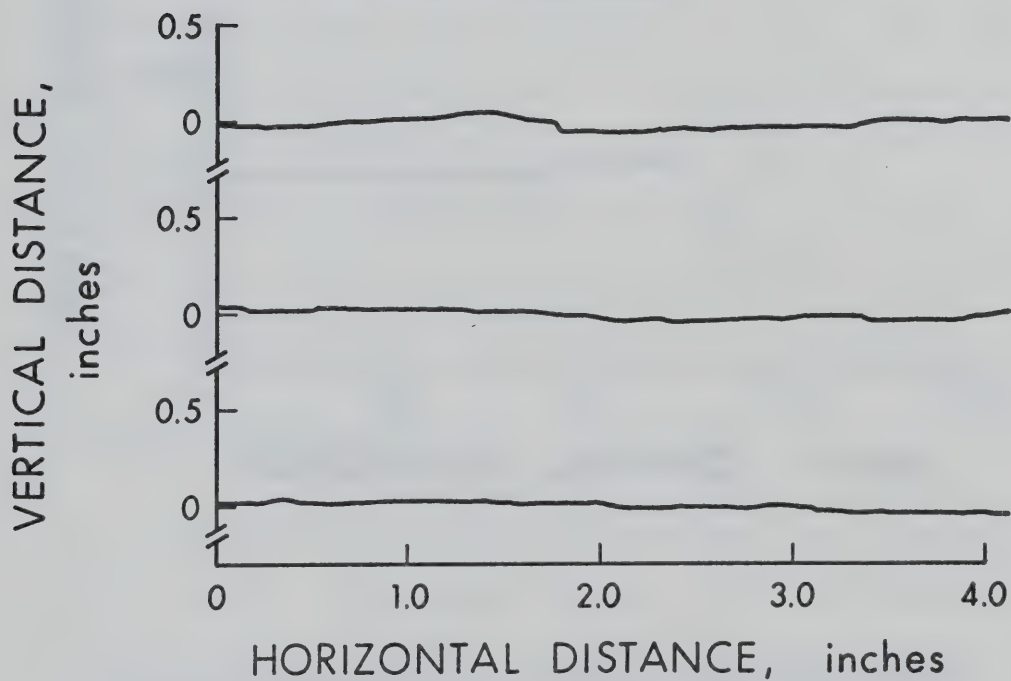
Fig.4.17 Roughness plots for Brenda calcite samples.

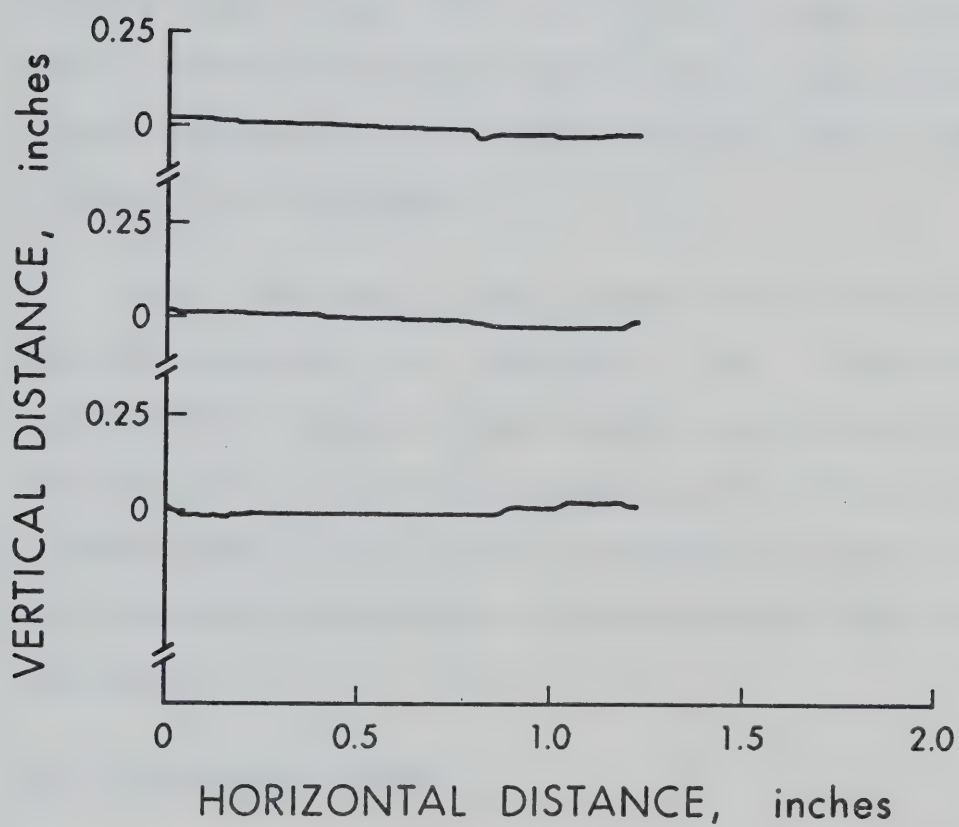
Fig.4.18 Roughness plot for Endako molybdenite sample.

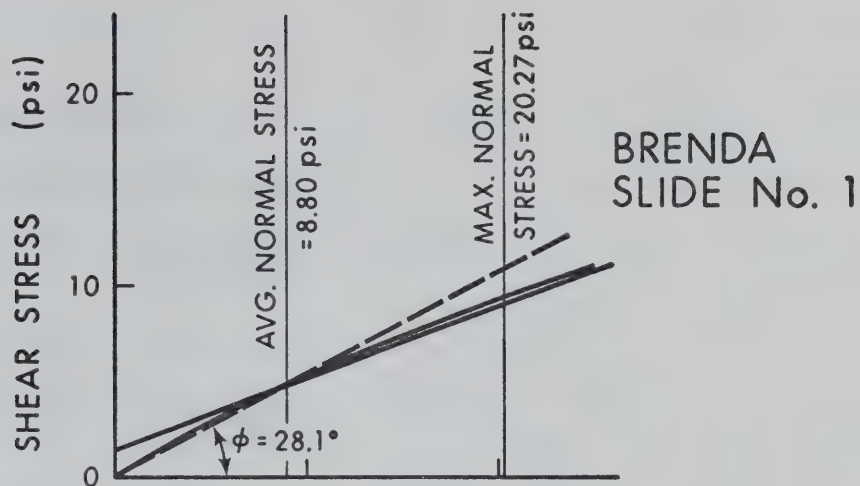
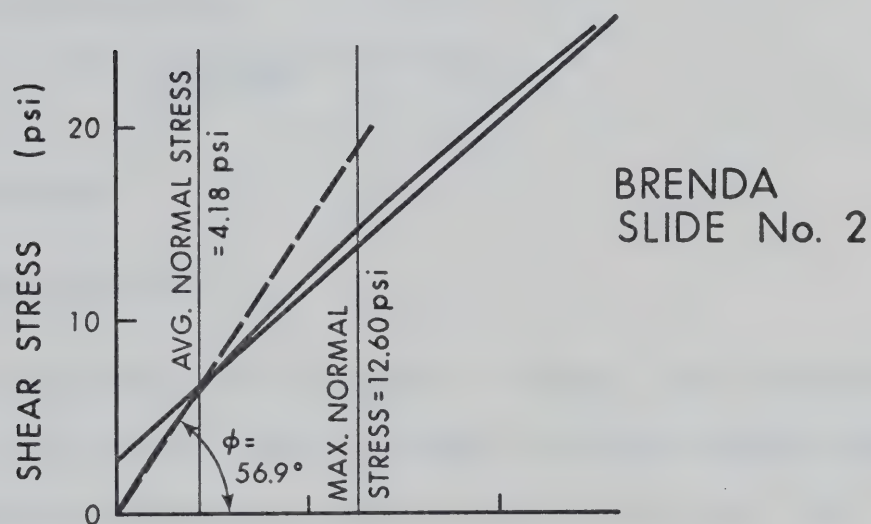
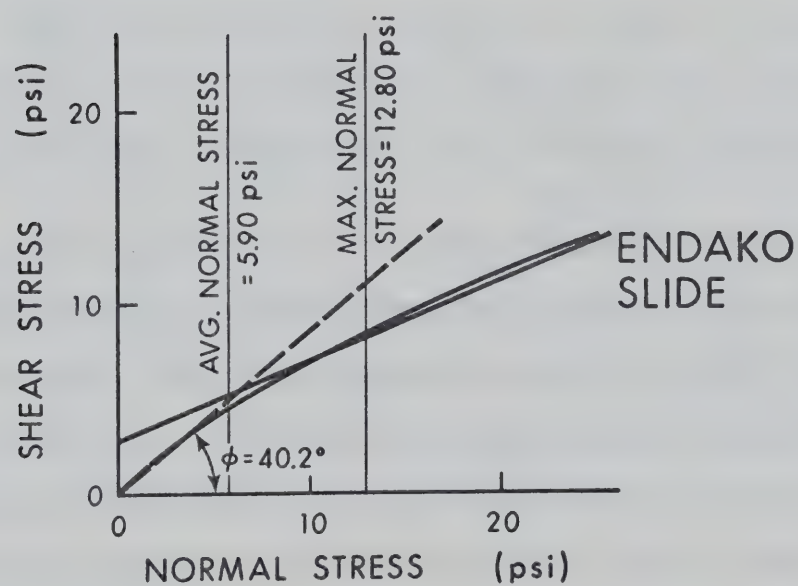
The differences in  $\tan \phi^1$  calculated from the two formulae were 2% to 14% of the average. Values of  $\phi^1$  are shown together with strength envelopes in Fig. 5.1

Fig 5.1 Equivalent friction angles for analyses of slides.

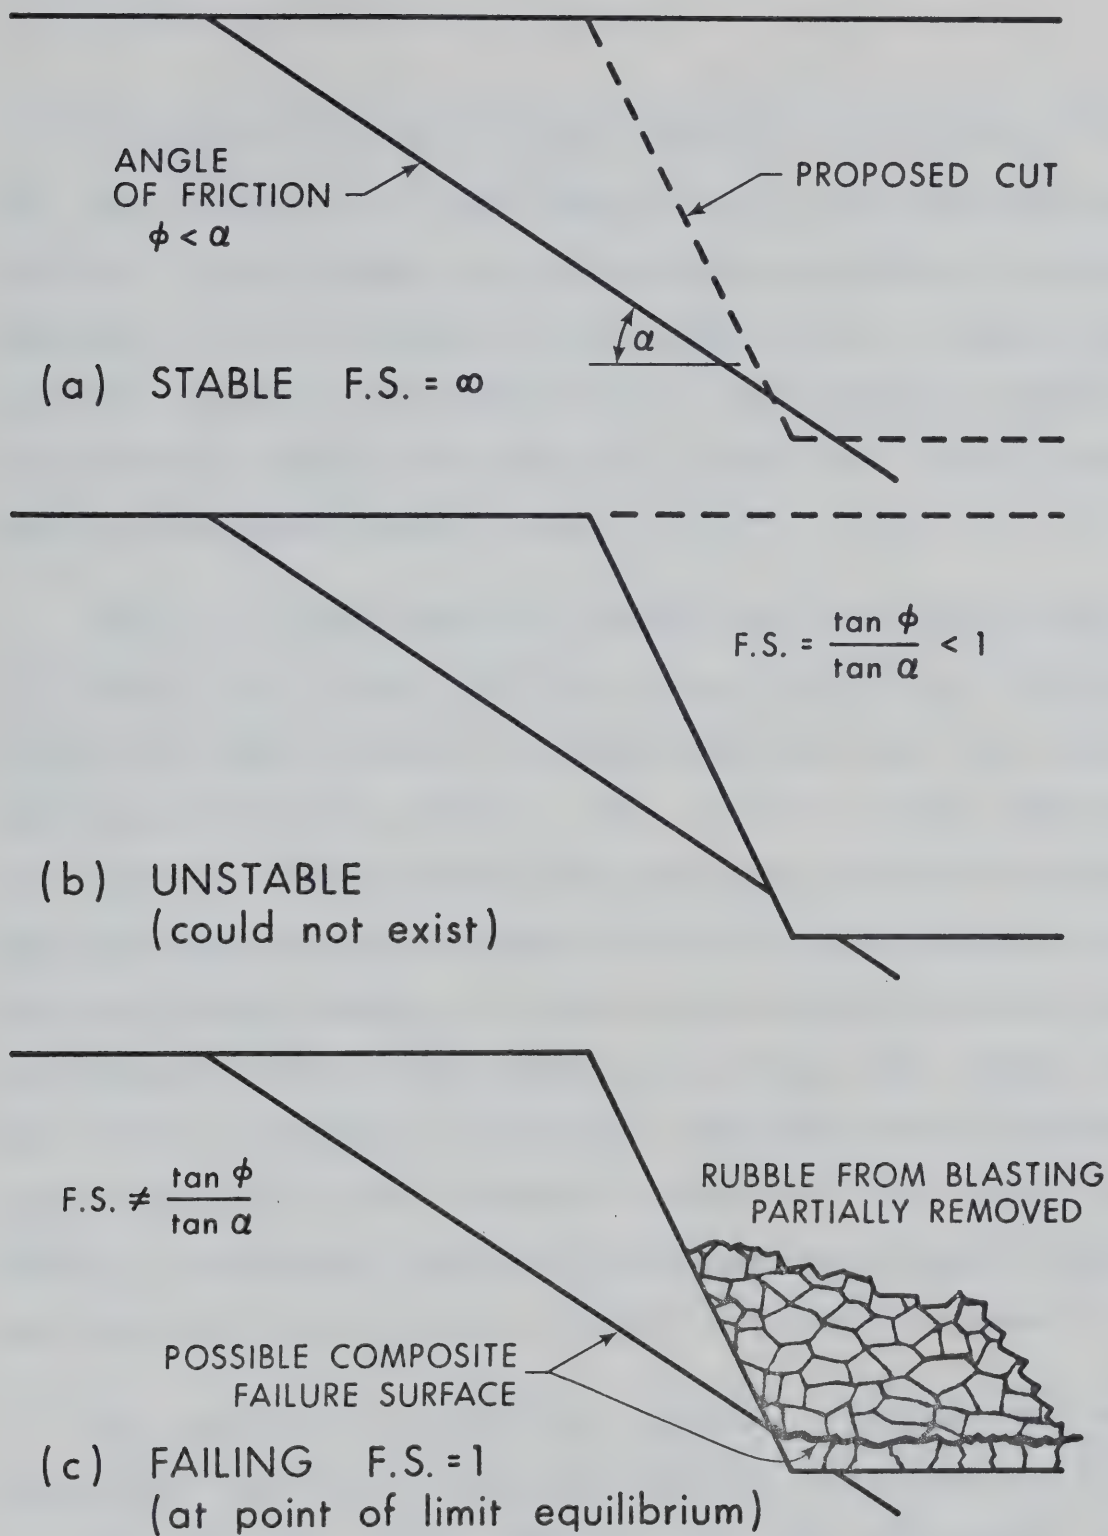
Fig.5.2 Possible failure conditions in rock slope with computed factor of safety less than unity.

In order to expect a factor of safety of unity in a back analysis it is implicitly assumed that a slide was at the point of equilibrium when failure occurred. Consider the proposed cut shown in Fig.5.2(a). Before the cut is made the area is stable because of the complete confinement provided by the material in the proposed cut. If the cut were made instantaneously failure would occur immediately (Fig.5.2(b)). The slope has 'passed through' the point of limit equilibrium.

In practice the cut is made gradually by blasting the cut, then hauling the rubble away. Part of the resistance to sliding of the slope is provided by the rubble, and this resistance will decrease as portions of the rubble are removed. At some point before all of the rubble is removed, the factor of safety will drop to unity, at which point failure will occur (Fig.5.2(c)).
